## Eco-Fasten Leak Test

EcoFasten Solar leak tested the Eco-Fasten roof mount system so you can be sure your roof penetrations wont leak, even when under standing water.

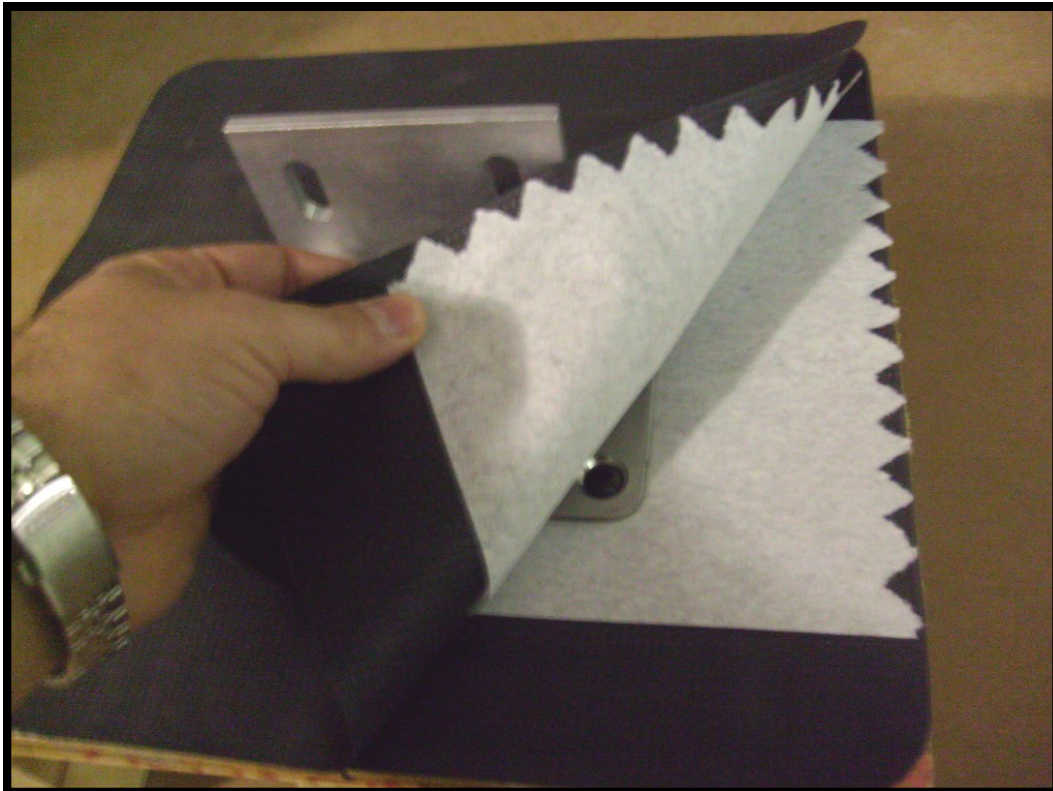
A paper towel was inserted above and below the base plate in this mock installation to provide a visual indication if any of the green water leaks past the flashing. The membrane is 45mil reinforced EPDM from Carlisle.

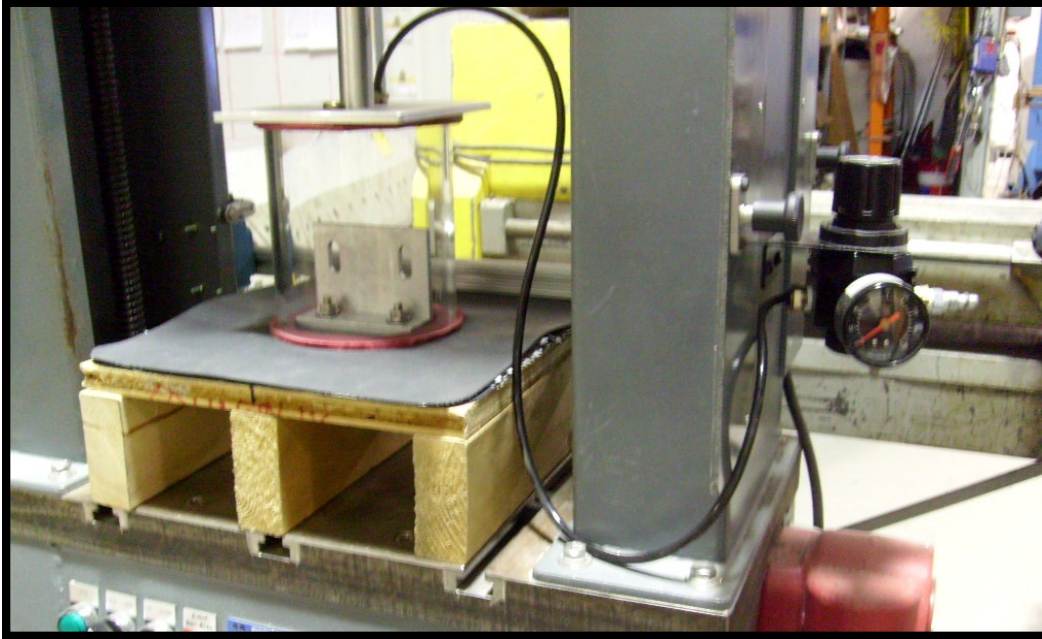
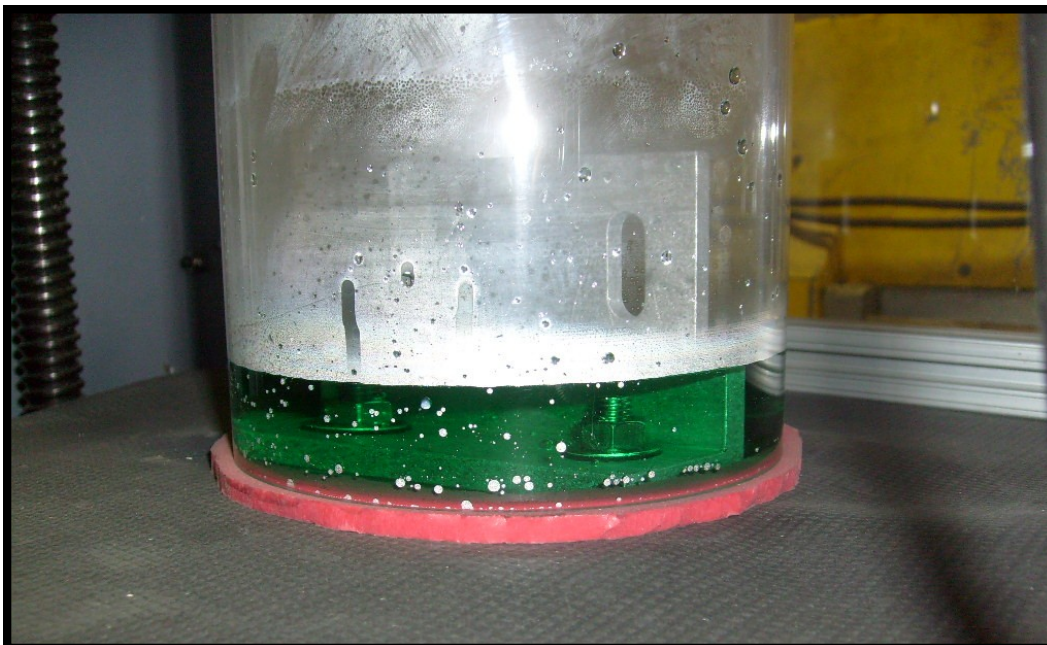
Our test apparatus encapsulates the entire bracket and seals against the membrane flashing which allows us to flood the bracket and pressurize the system.

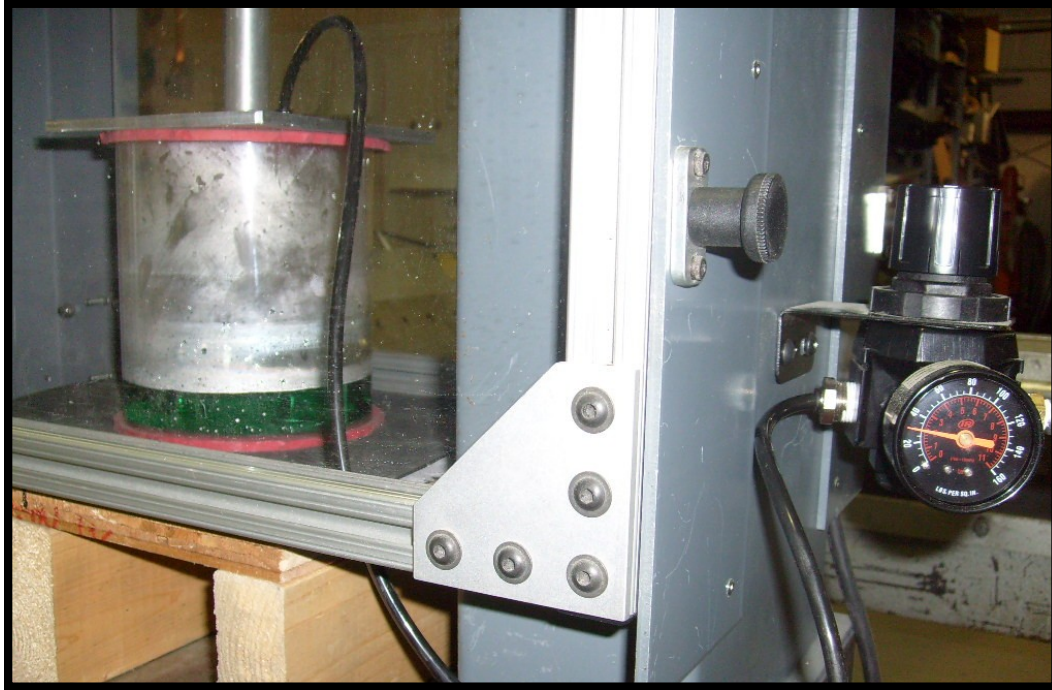
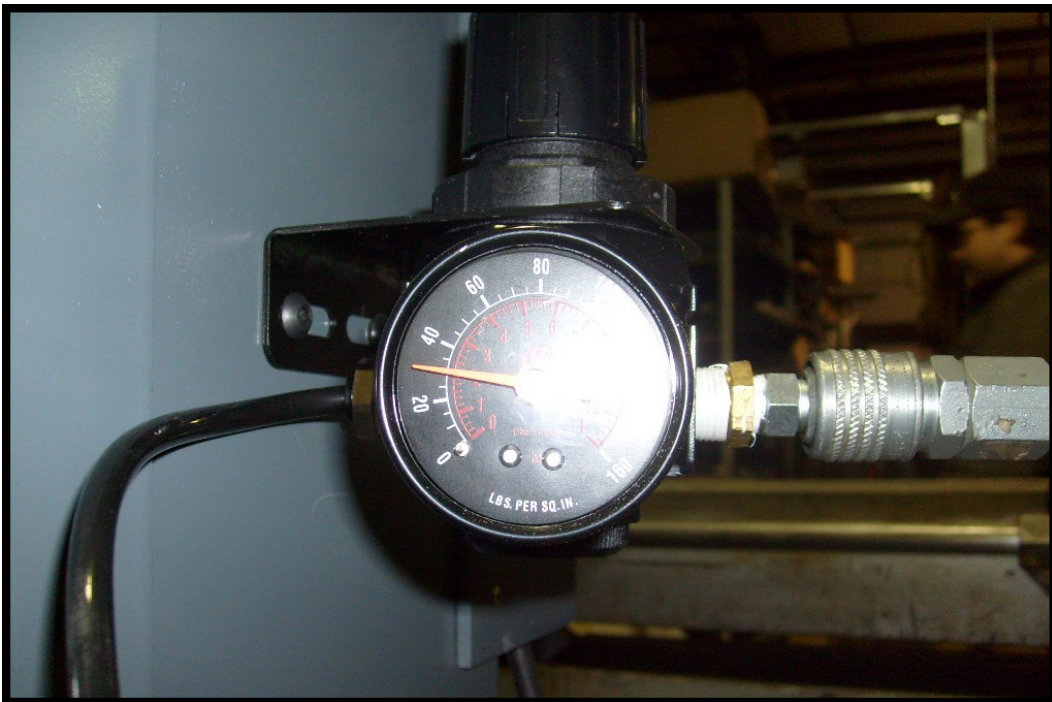
The apparatus is then pressurized to 30psi and left to stand for over 10 minutes. This is equivalent to nearly 70ft of standing water!

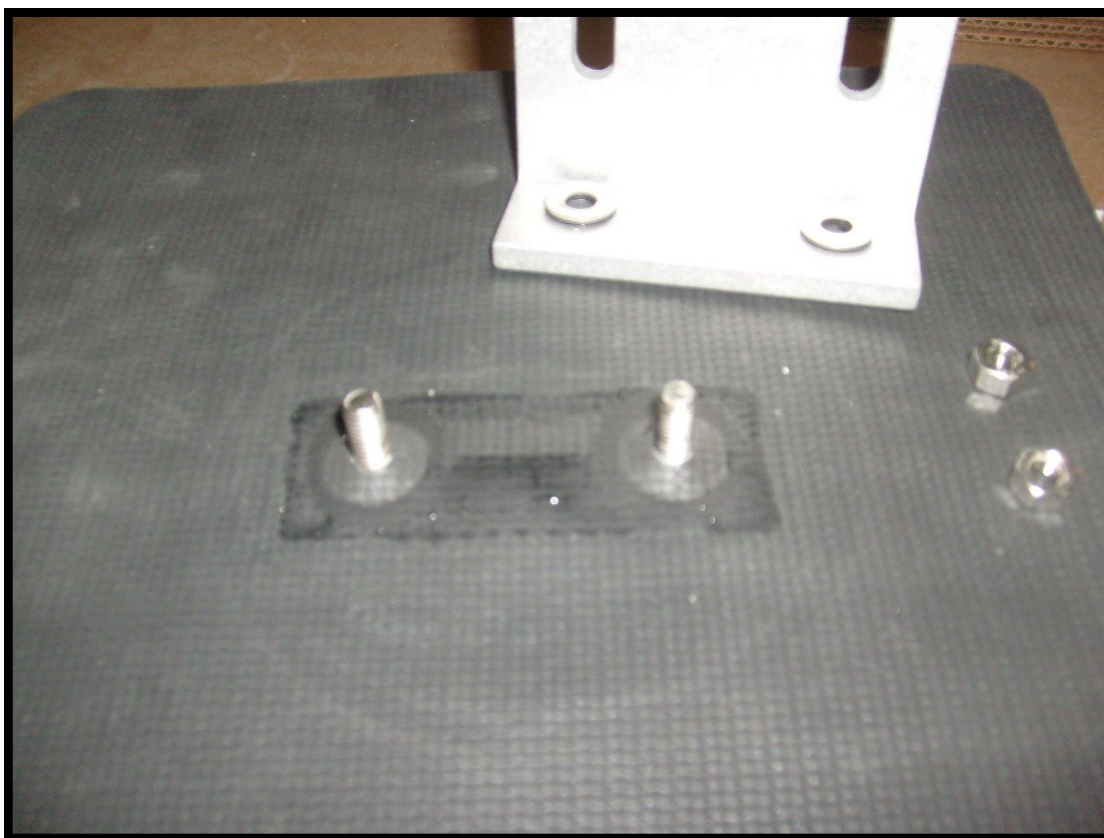
This picture shows that it is the patented compression fitting between the cone shape of the base plate and the countersink in the bracket that makes the Eco-Fasten system water tight. Water finds its way between the bracket and membrane but stops at the base of the compression fitting and can go no further.

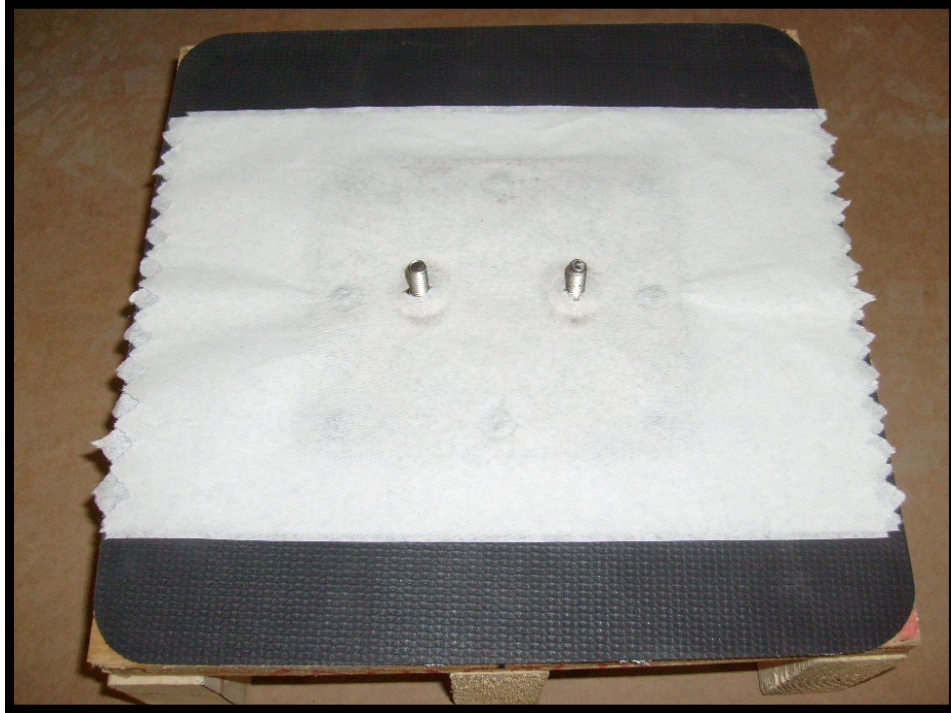
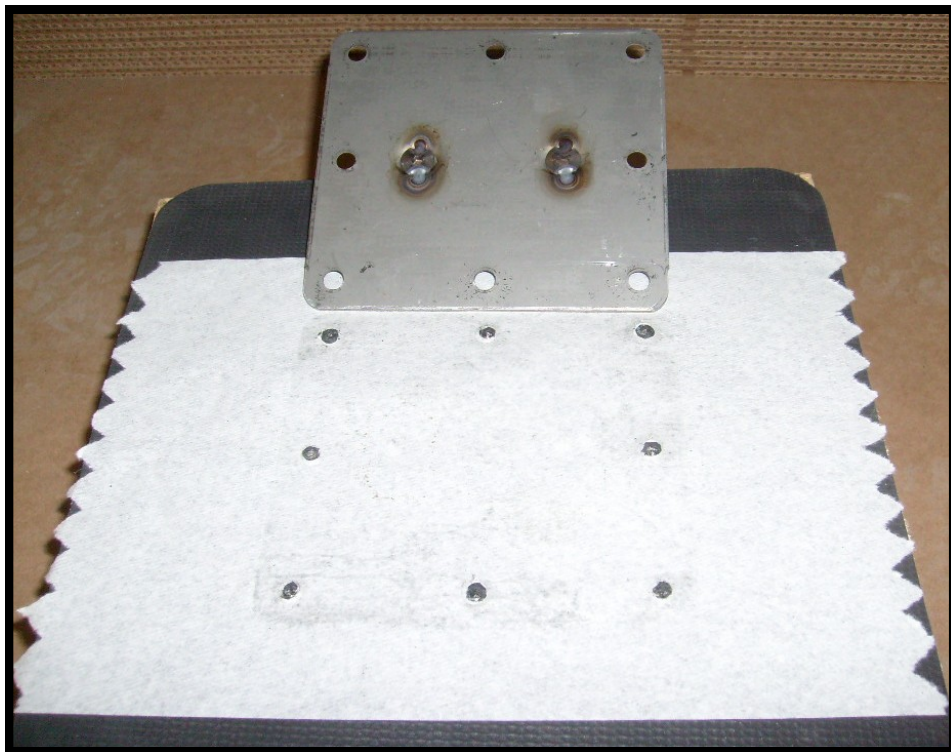
Neither of the paper towels show any indication of leaking. The Eco-Fasten system is 100% water tight.
